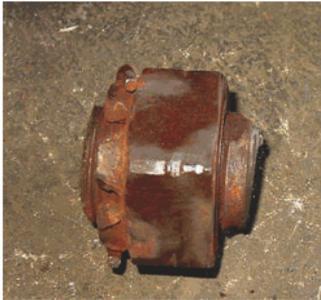
Figure 2. Location of fatigue fracture in a change of section on the pump shaft.

The load causing the failure is assumed to be the bending stress caused by the actual angular misalignment being larger than that allowed by the over-running clutch coupling. The original motor support frame had been replaced and it is possible that a slight dimensional difference caused misalignment. Maintenance engineers ought to have recognized the additional care required by this type of coupling during alignment and demanded more accurate work from the maintenance operators and the use of more precise tools for the job. The change of section on the shaft behind the thread is the fully loaded stress raiser nearest to the load application point, the rest of the pump shaft being very smooth.

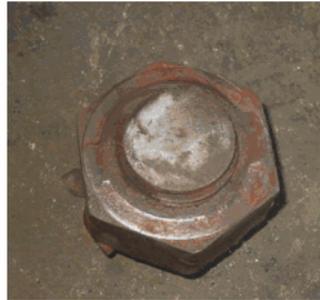
Figure 3. Appearance of pump shaft fatigue fracture surface.

of symmetric bending stress in rotation acting over a low stress concentration factor at a moderate cyclic load (Figure 3).

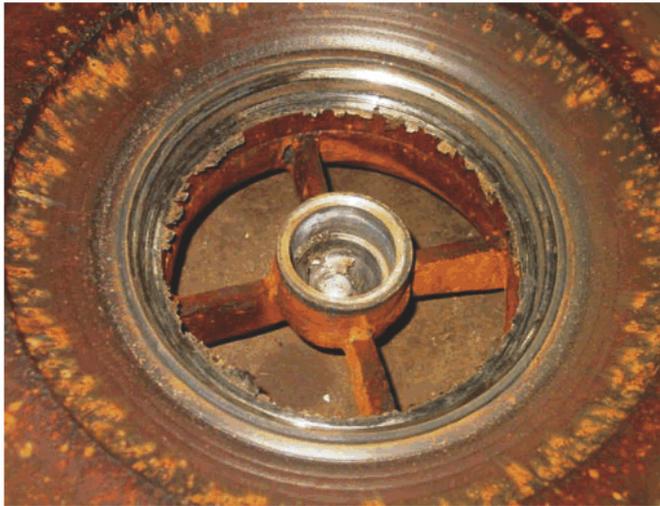
Figure 4. Damage to first-stage casing, wear ring and bottom bush.

After the failure of the shaft, the coupling hub and the thrust bearing inner ring are free and the whole pump rotor is also free to move downwards, while still rotating at high speed, until it collides with the pump first-stage casing and bottom bush. Damage to the first-stage casing, first-stage casing wear ring and bottom bush are shown in Figure 4, while Figure 5 shows the damage to the first-stage impeller front shroud and wear ring.

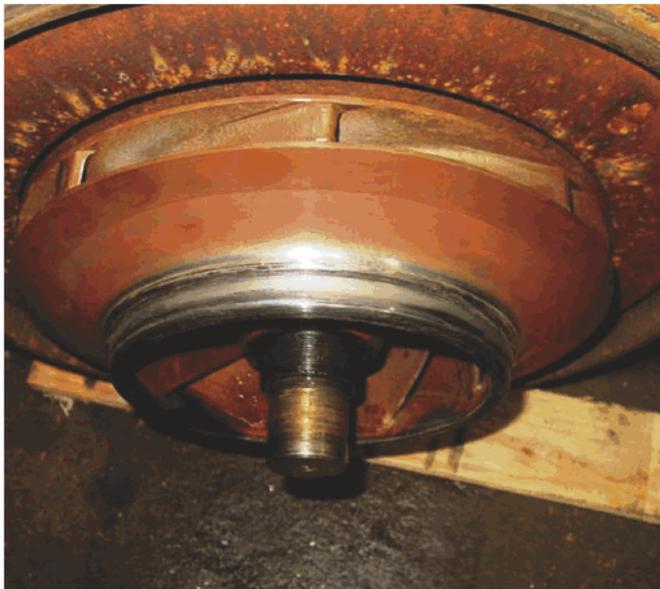
Figure 5. Damage to first-stage impeller front shroud and wear ring.
