Thermographic Inspection

Information report

Company:	Industry
Your ref:	PO-1000
Our ref:	5000
Operator:	Erik Sørbøsveen
Date of insp:	15.02.02 - 17.02.02

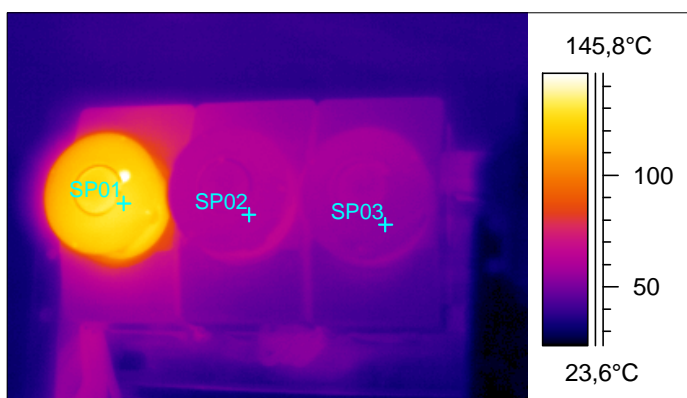
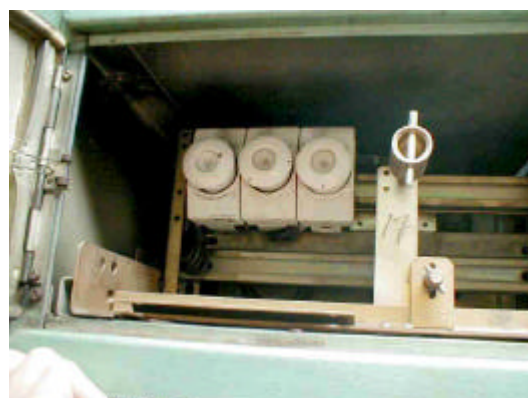
IR-Report no: 4
Place: Switchboard room 1
Equipment: S-1001, section 4:1
Description: Distr. Hvac
Controlpoint: UZ-element, phase L1

Measuringvalues / Condition

Measurepoint	Load	Temperature
SP01	40 A	130,5°C
SP02	42 A	60,7°C
SP03	39 A	54,0°C

Normaltemp. (reference)	45°C
Diff SP01-Normaltemp.	85,5°C
Ambient temp.	18,0°C

Grade 3

Poor bottomscrew or fuse causes the critical temperature. Immediate repair to be done.

UZ-element to be changed. Do also check wires for damage.

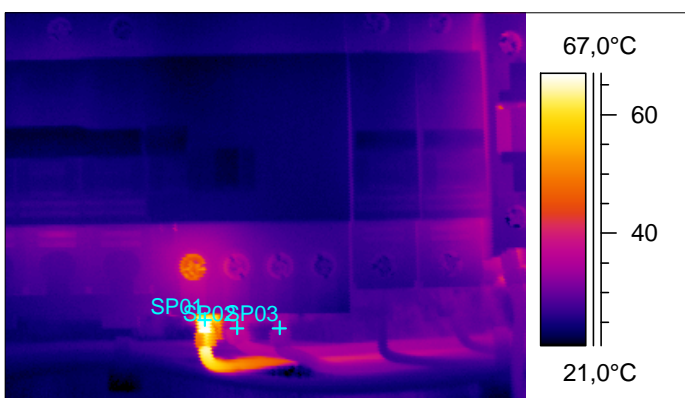
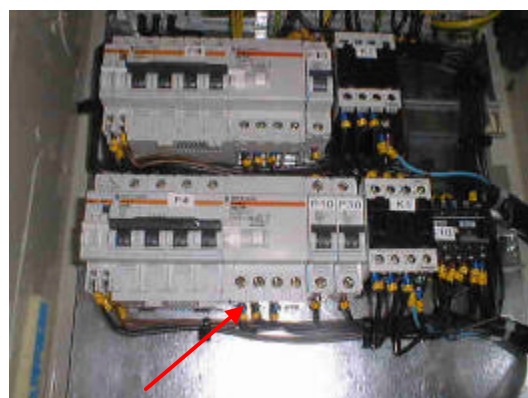
IR-Report no: 5
Place: Switchboard room 2
Equipment: DB-1060
Description: Distr. heattrace
Controlpoint: Earthfault breaker for F4

Measurepoint	Load	Temperature
SP01	6 A	67,0°C
SP02	6 A	37,4°C
SP03	9 A	32,9°C

Normaltemp. (reference)	32°C
Diff SP01-Normaltemp.	35,0°C
Ambient temp.	20,0°C

Grade 2

L1 wire is connected at the wrong side of the clip and causes this hotspot.

Wire to be redone. Check wire and clip for damage of heat.

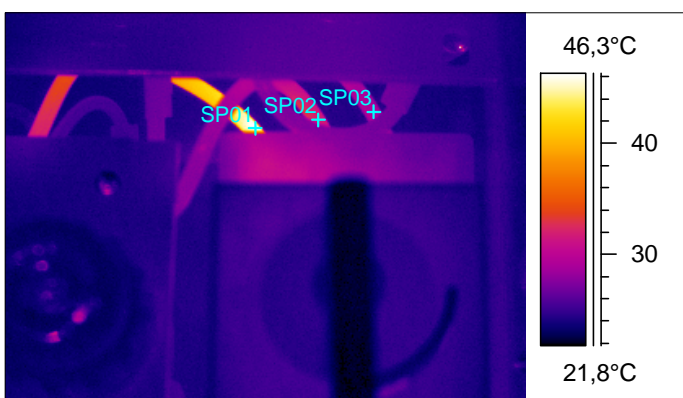
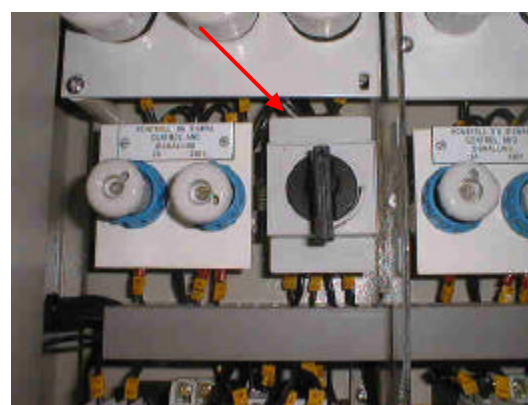
IR-Report no: 6
Place: Switchboard room 2
Equipment: DB-1010
Description: Mainswitch, circuit 8
Controlpoint: Phase L1

Measurepoint	Load	Temperature
SP01	5,2 A	46,8°C
SP02	5,2 A	32,0°C
SP03	5,2 A	29,0°C

Normaltemp. (reference)	28°C
Diff SP01-Normaltemp.	18,8°C
Ambient temp.	15,0°C

Grade 2

This is the supply for circulation pump no 3. Wire underneath breaker cover is probably loose.

Check/retorque all terminals underneath breaker cover in a suitable period.

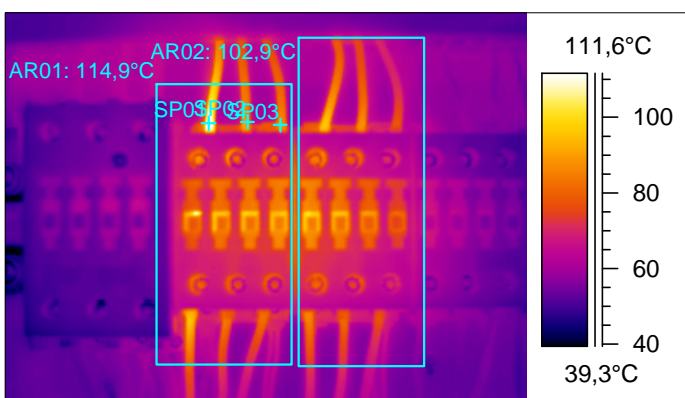
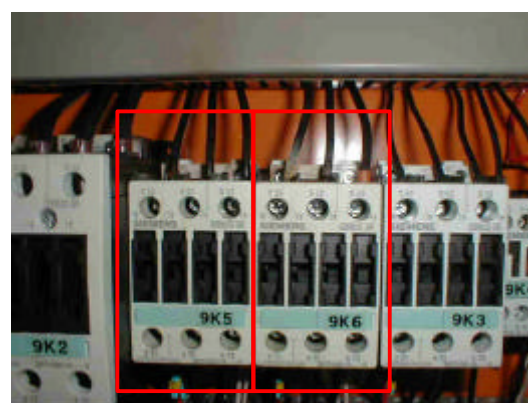
IR-Report no: 7
Place: Switchboard room 2
Equipment: DB-101
Description: 9K5 and 9K6
Controlpoint: Dimension problem

Measurepoint	Load	Temperature
SP01	21,5 A	114,6°C
SP02	21,5 A	88,3°C
SP03	21,5 A	87,6°C

Normaltemp. (reference)	55°C
Diff SP01-Normaltemp.	59,6°C
Ambient temp.	22,0°C

Grade 3

Both contactors and wires on these circuits have a dimension problem. Burnmarks on wires (2,5 mm²) and very high temperature on the contactors. Wires in cable-channel are over 70°C.

Increase dimensions on both contactors and wires. Immediate repair to be done.

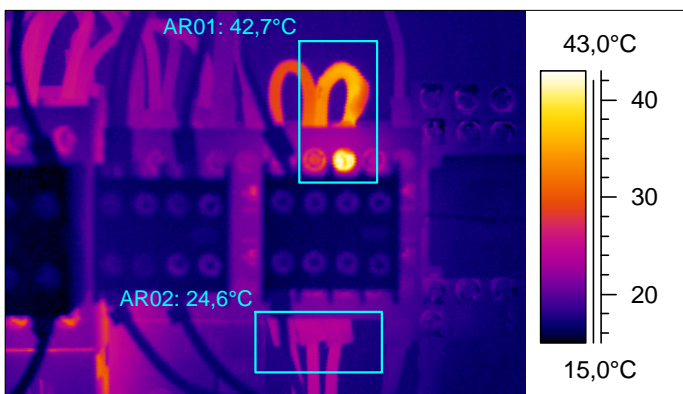
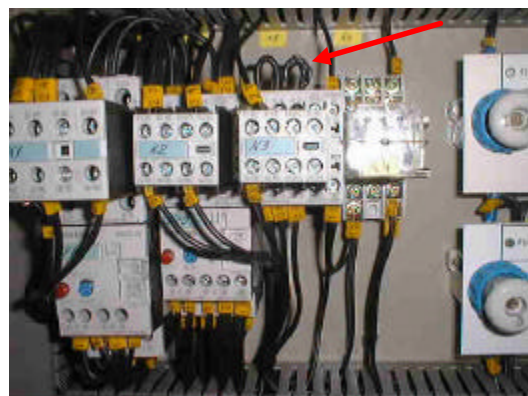
IR-Report no: 8
Place: Switchboard room 3
Equipment: DB-1013
Description: K3 (High speed contactor)
Controlpoint: Link L2 to L3

Measurepoint	Load	Temperature
AR01:max	6 A	42,7°C

Normaltemp. (reference)	25°C
Diff AR01:max - Normaltemp	17,7°C
Ambient temp.	15,0°C

Grade 3

This is the highspeed contactor for the supplyfan. The wirelink is burned and have been much warmer at a earlier stage.. The connection clip is burned and "black" as well. Do only run this fan on lowspeed until contactor has been replaced.

Contactor and wirelink to be changed. **Contactortype: Siemens G/990512#E04# / 3RT1017-1AP01**

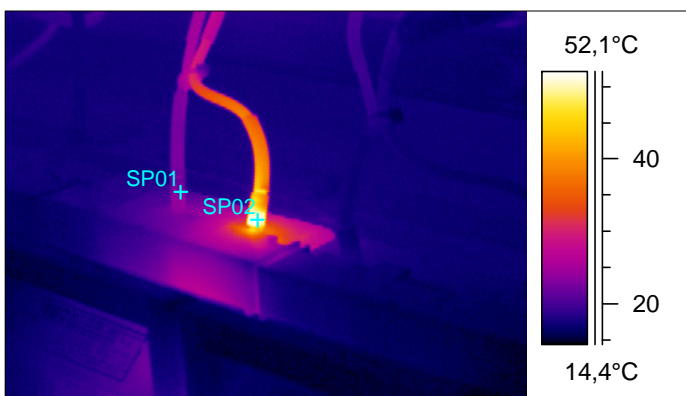
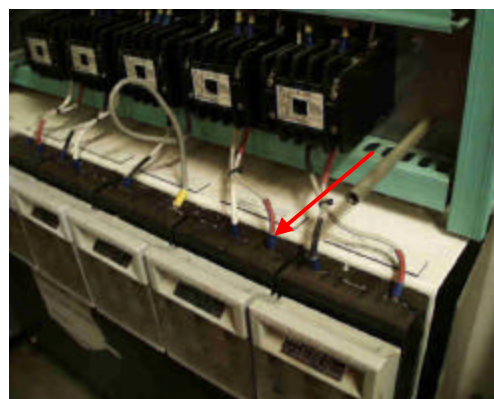
IR-Report no: 9
Place: Switchboard room 4
Equipment: LP-2086
Description: Hvac, power section
Controlpoint: Breaker Q-2050

Measurepoint	Load	Temperature
SP01	9 A	22,8°C
SP02	9 A	52,1°C

Normaltemp. (reference)	22°C
Diff SP02-Normaltemp.	30,1°C
Ambient temp.	16,0°C

Grade 2

This breaker is located at the right hand side. Poor cables shoe is probably the reason for this heatup, but it could be a poor fuseclamp inside breaker as well.

Replace cables shoe and check fuseclamp for damage.

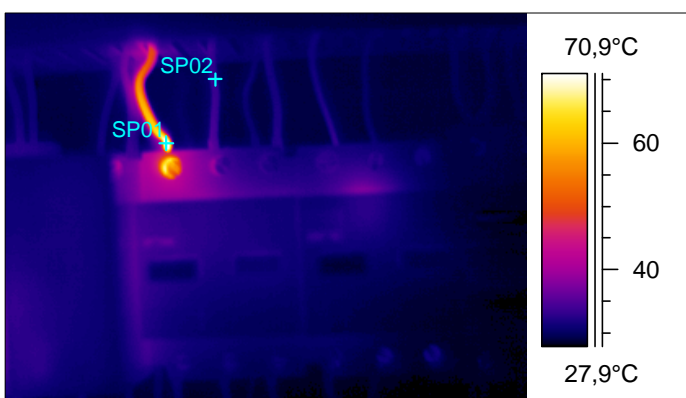
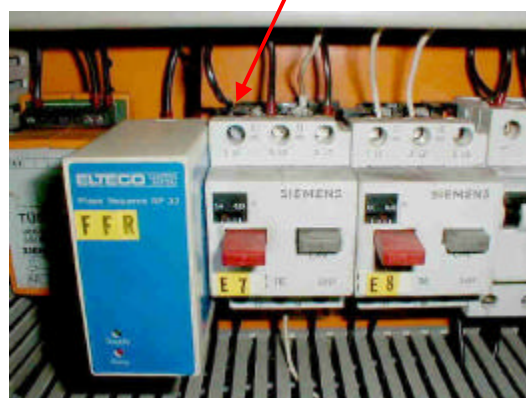
IR-Report no: 10
Place: Elevator room
Equipment: Elevator panel
Description: Protection breaker E7
Controlpoint: Connection 1 (L1)

Measurepoint	Load	Temperature
SP01	0,2 A	74,5°C
SP02	0,2 A	33,2°C

Normaltemp. (reference)	33°C
Diff SP01-Normaltemp.	41,5°C
Ambient temp.	30,0°C

Grade 3

Connection clip is wide open and both wire and clip is burned.

Protection breaker and wire to be replaced immediately. **Type: Siemens 11E 3VE1.**

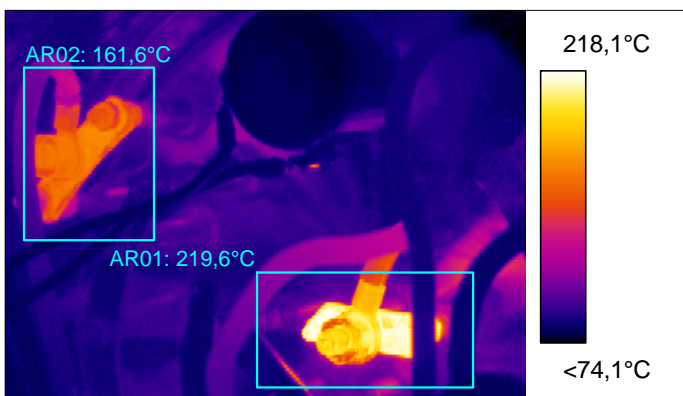
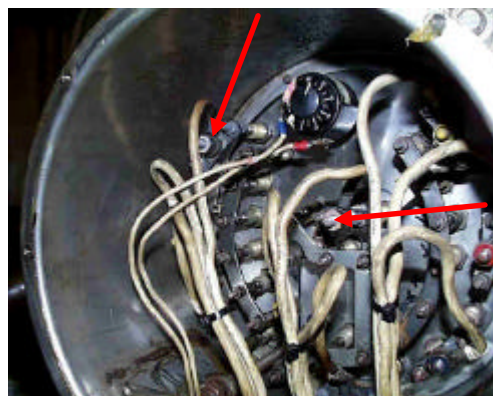
IR-Report no: 11
Place: Boiler room
Equipment: H-1302C
Description: Hotwater-heater
Controlpoint: Heater elements

Measurepoint	Load	Temperature
AR01:max	34 A	219,6°C

Normaltemp. (reference)	55°C
Diff AR01:max - Normaltemp	164,6°C
Ambient temp.	15,0°C

Grade 3

Critical temperatures on two connection-points for heatelements. Immediate repair to be done.

Cablesheets to be replaced and a general cleanup on all connectionpoints/wires inside this box must be done. Check heater elements for damage, they might be changed as well.

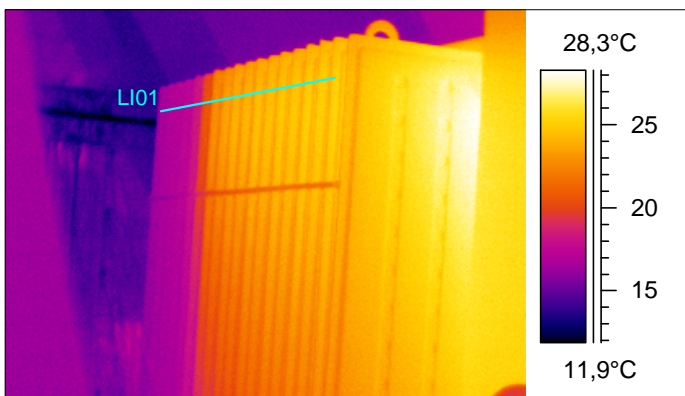
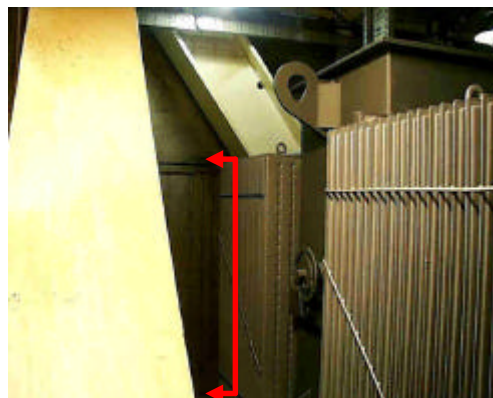
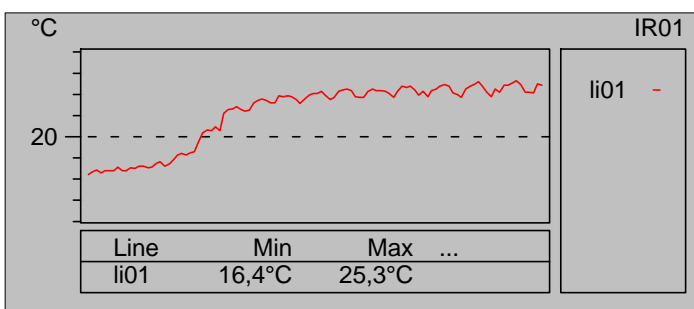
IR-Report no: 12
Place: Transformer room
Equipment: T-1003
Description: 6,6kv/440V trafo
Controlpoint: Cooling ribs prim. side

Measurepoint	Temperature
LI01:max temp.	25,3°C
LI01:min temp.	16,4°C
Normaltemp. (reference)	25°C
Diff Normaltemp. - LI01:min	8,6°C
Ambient temp.	15,0°C

Grade 1

There is a marked temperature-dropp on six of the cooling ribs furthest out. Could it be dirt inside that obstruct oil-circulation?

To be confirmed by supplier.
