HISTORY SUMMARY

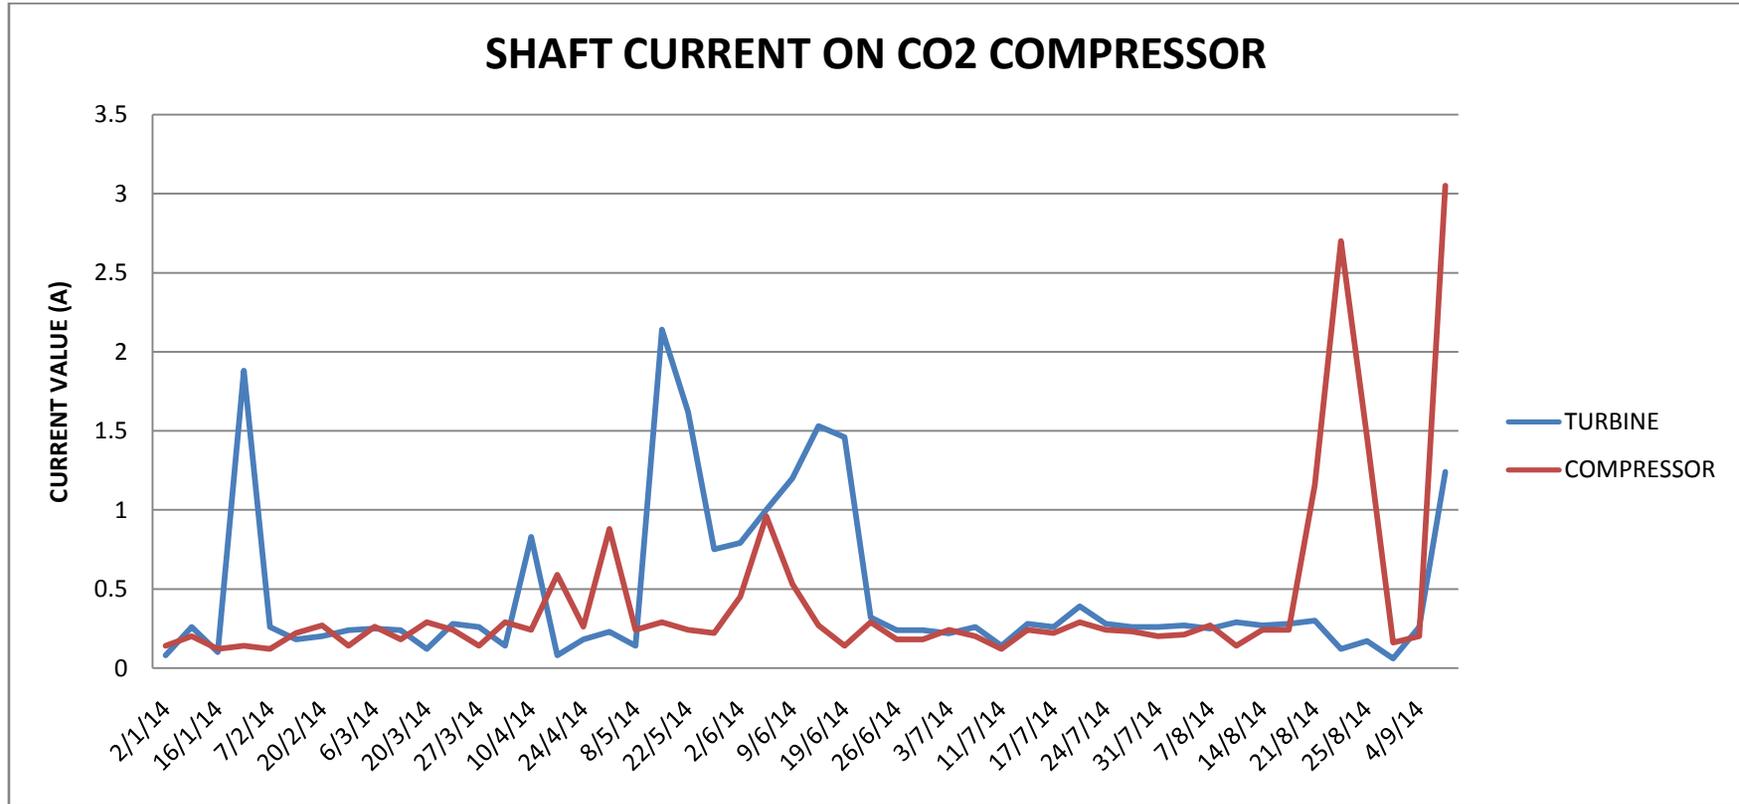
1. Shaft current measured through earth brush on TB side and HP compressor side.
